From 1935 to 2026: How 3D Printing Revived an “Unfixable” Heritage Asset

MAWDSLEYS

CIRENCESTER
OPEN AIR
SWIMMING POOL

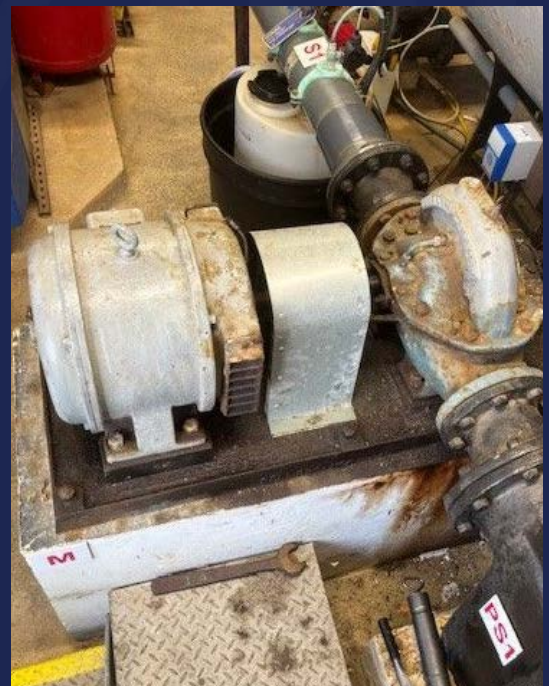
The 1935 split-case pump and motor were facing the inevitable toll of nine decades of service. The facility faced several critical obstacles:

- **Critical Vulnerability:** The pool operates with a single circulating pump. There is no backup. If the pump fails during the five-month season, the pool is forced to shut down immediately, resulting in a total loss of community service and vital charity income.
- **Symptomatic Failure:** The system was pulling air through blown seals, and the motor was frequently tripping out upon startup, suggesting deep-seated electrical faults.
- **Obsolete Engineering:** All fasteners and components were based on old-style imperial sizing. Finding off-the-shelf parts for 1930s Bell Brothers equipment is a mechanical impossibility.

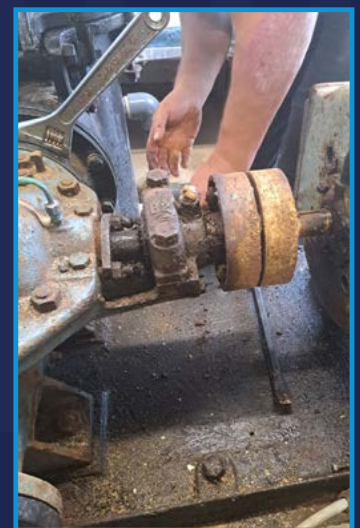
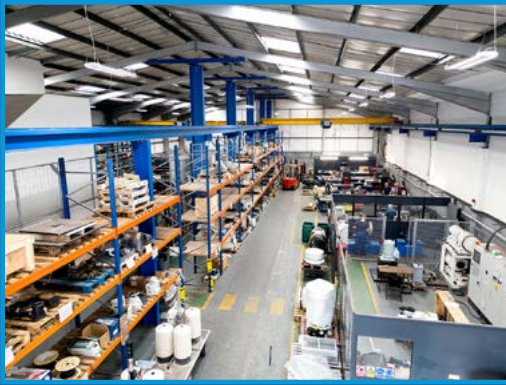
The Motor Overhaul

Upon dismantling, the windings were found to be unserviceable. Our specialists performed a full stator rewind, followed by a steam and stove process to ensure insulation integrity. We replaced the bearings with high-performance RMS10 and MRJ1 3/8 rollers and dynamically ran the motor to ensure it met modern performance standards.

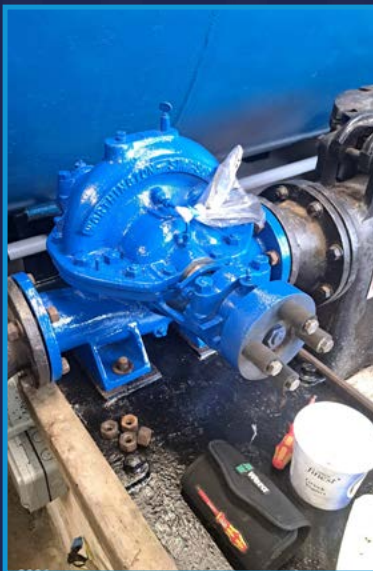
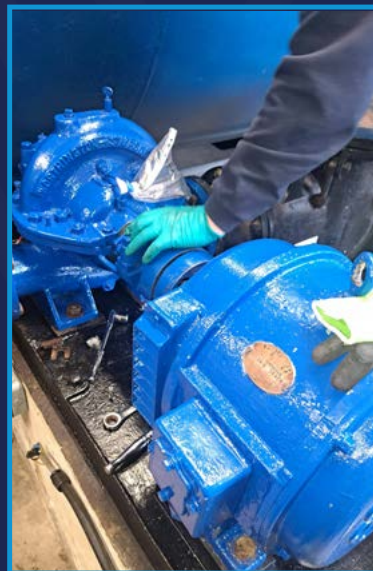
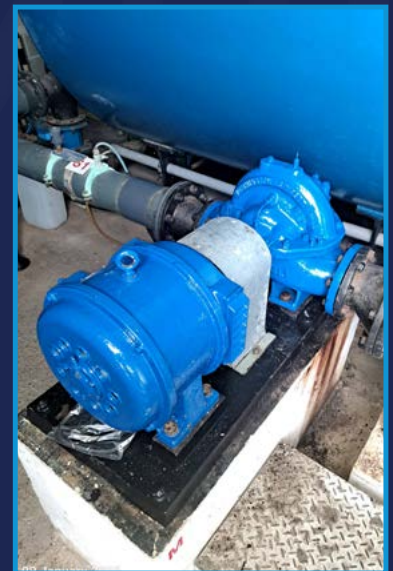
The 3D-Printing Breakthrough

The most significant hurdle was the failed lantern rings and worn impeller neck rings. With no replacements available globally, Toby, a Mawdsleys BER engineer, took a modern approach to this vintage problem. Toby hand-measured the worn components and used 3D-printing to manufacture bespoke replacements from high-grade nylon. It deforms slightly under pressure, making it excellent for sealing while providing low resistance due to its naturally lubricious properties.

By insourcing the manufacturing via 3D printing, we eliminated external lead times and provided a custom-engineered solution that was literally made to measure for the 1935 housing.
